BUREAU OF SHIPS GROUP TECHNICAL INSPECTION REPORT

U.S.S. INDEPENDENCE (CVL22)

TEST ABLE

VOLUME 4 OF 4

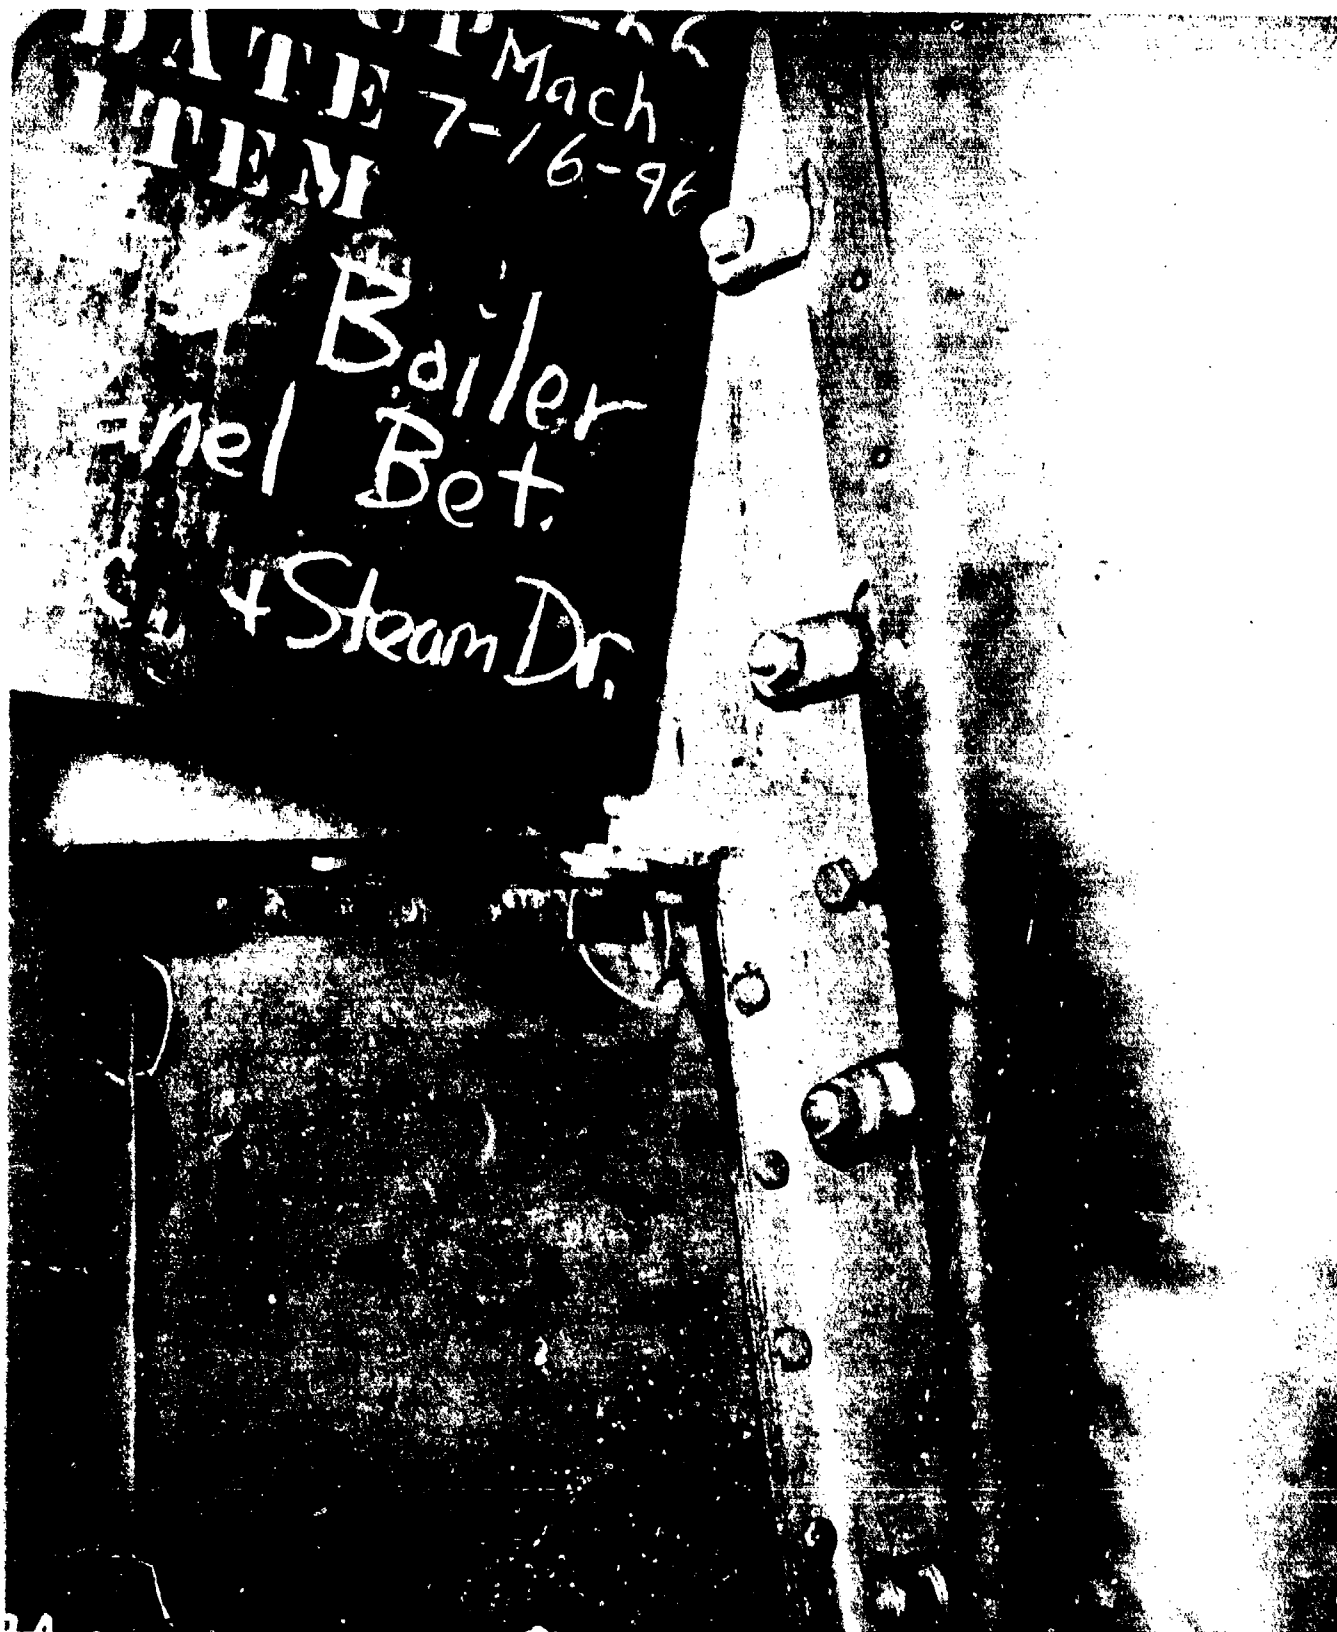
AA-CR-62-2172-8. #3 Boiler panel, between economizer and steam drum.

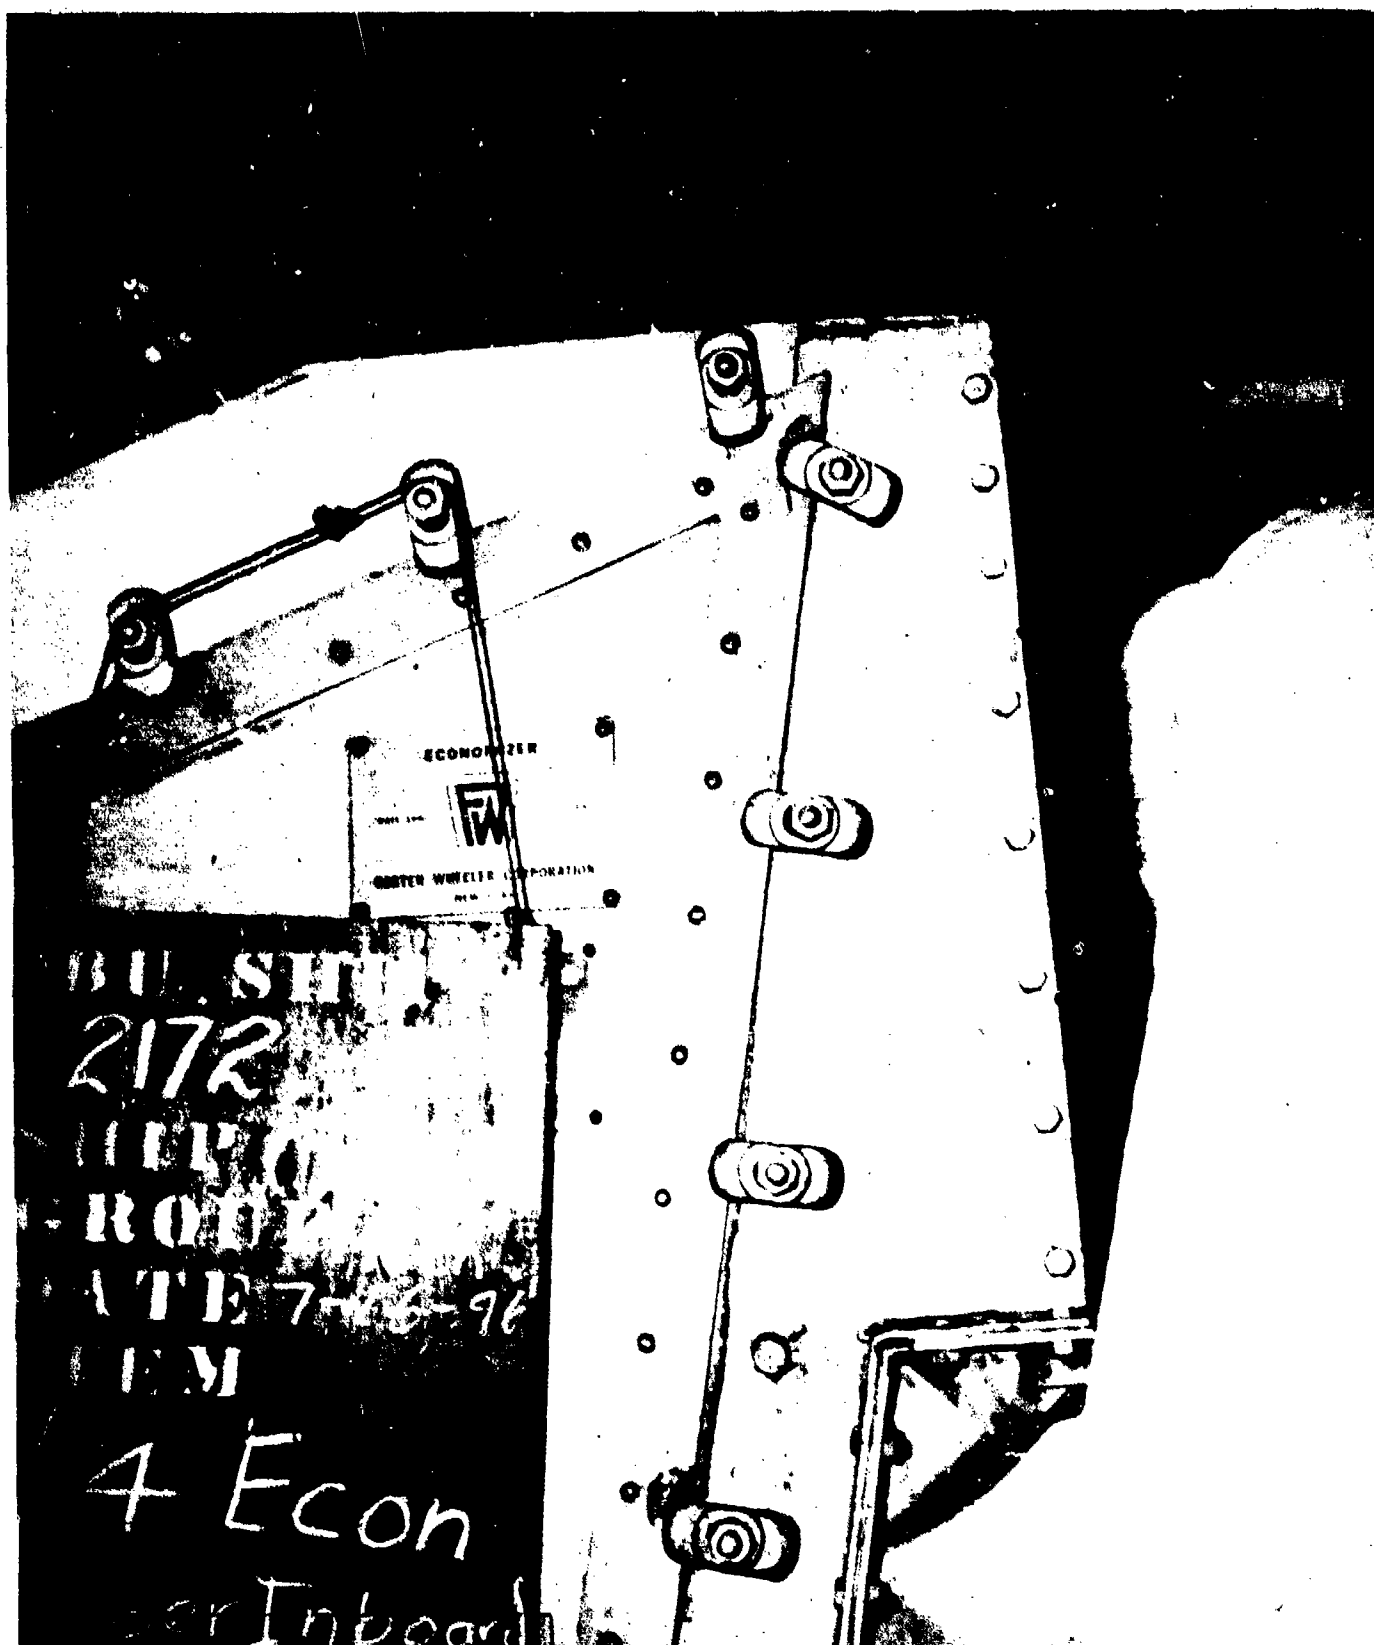
AA-CR-62-2172-7. Economizer, upper front inboard corner.

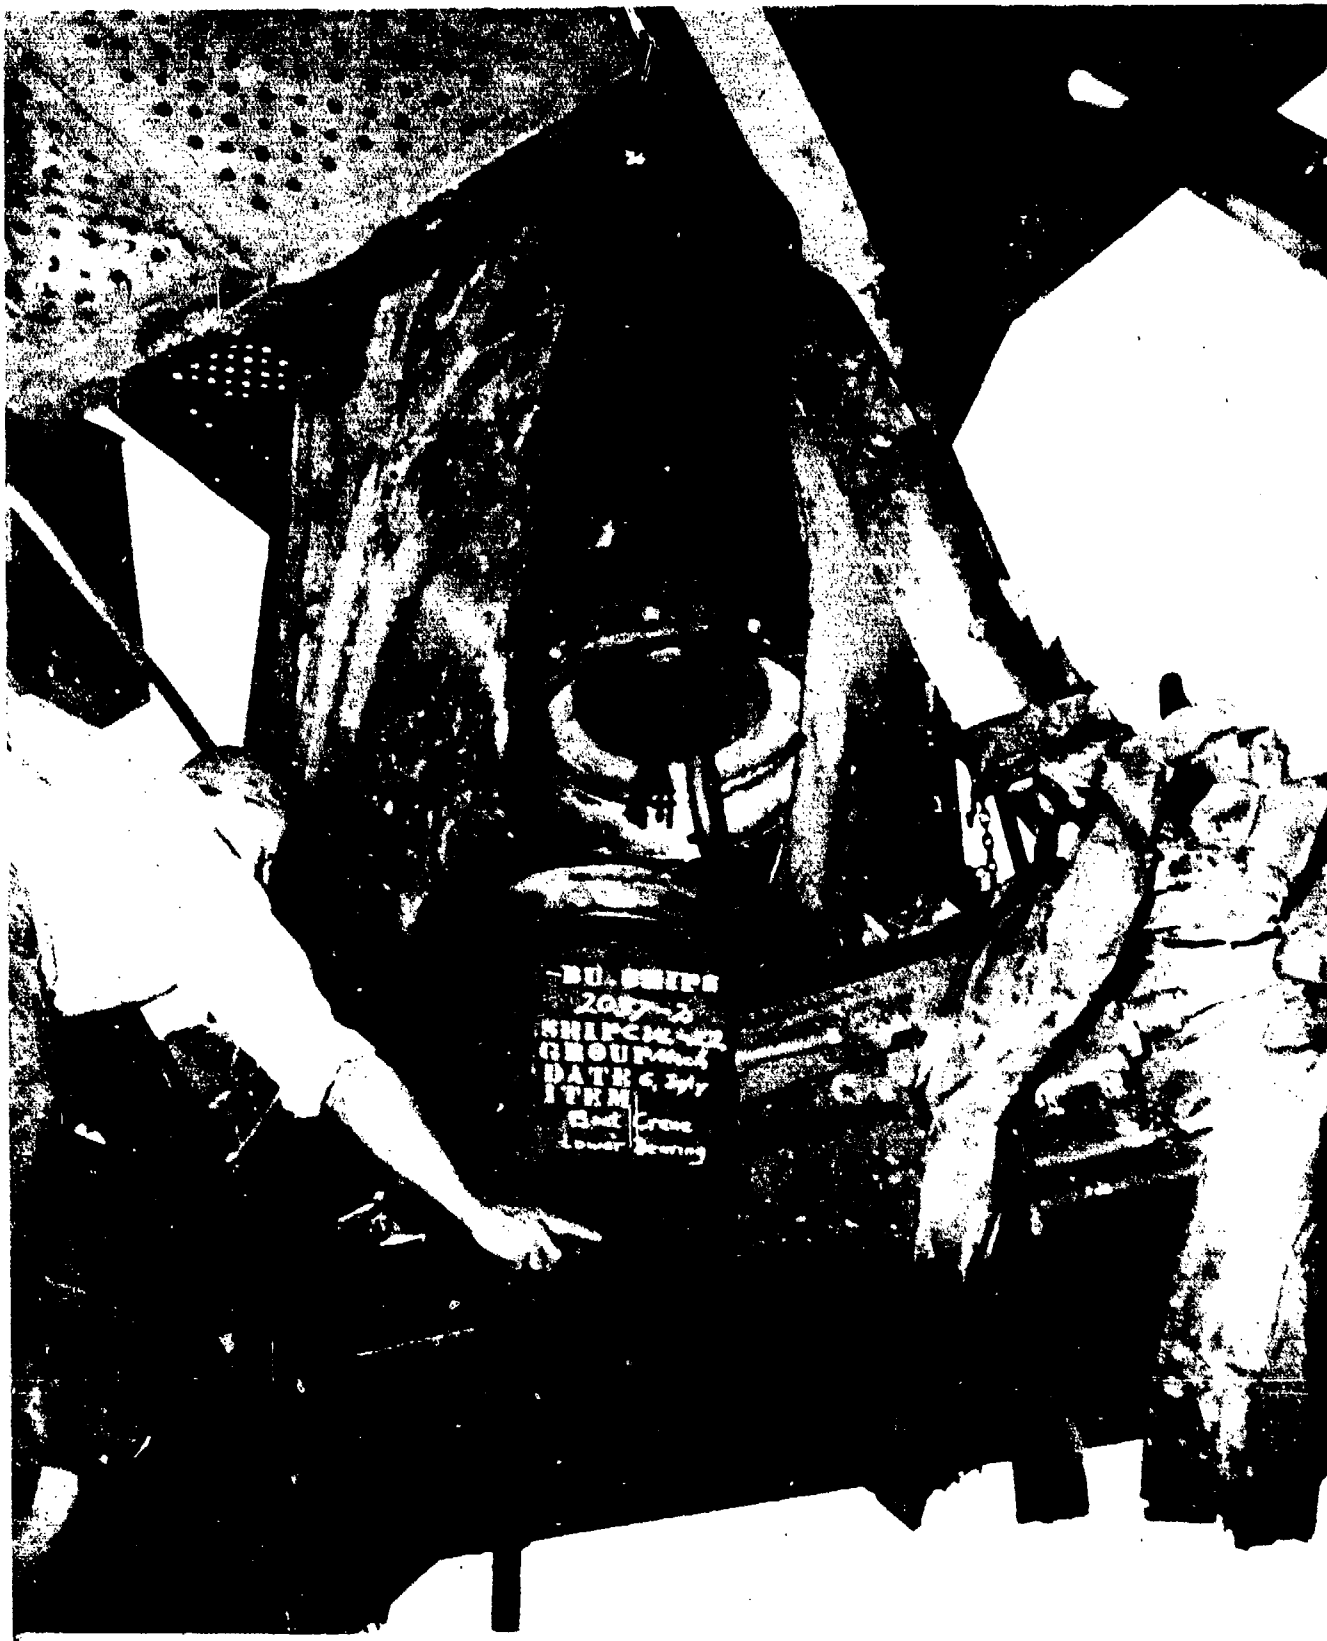
AA-CR-175-2037-2. Boat crane, lower bearing.

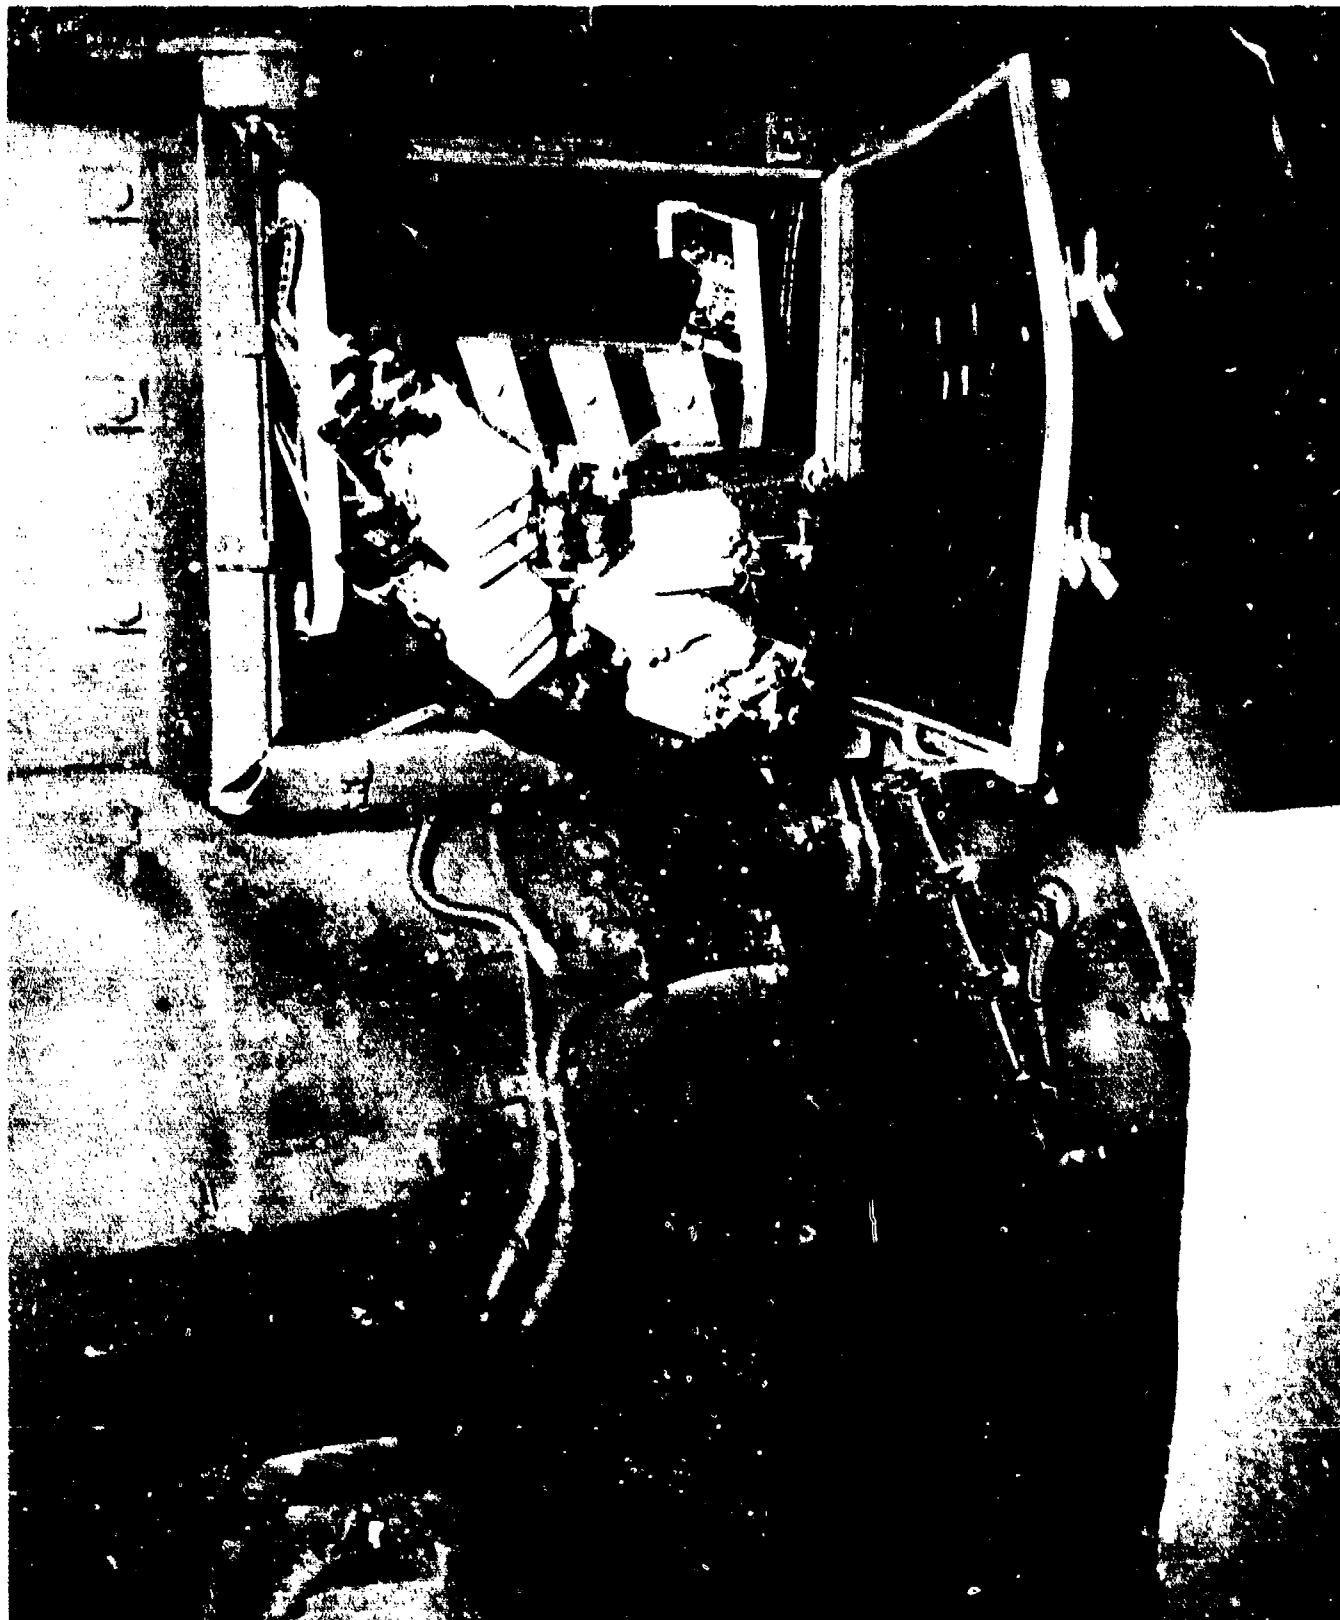
AA-CR-62-1881-6. Damaged transformer and power panel # 3-101-1 on gallery deck level frame 103 starboard in gun crew shelter, view looking aft.

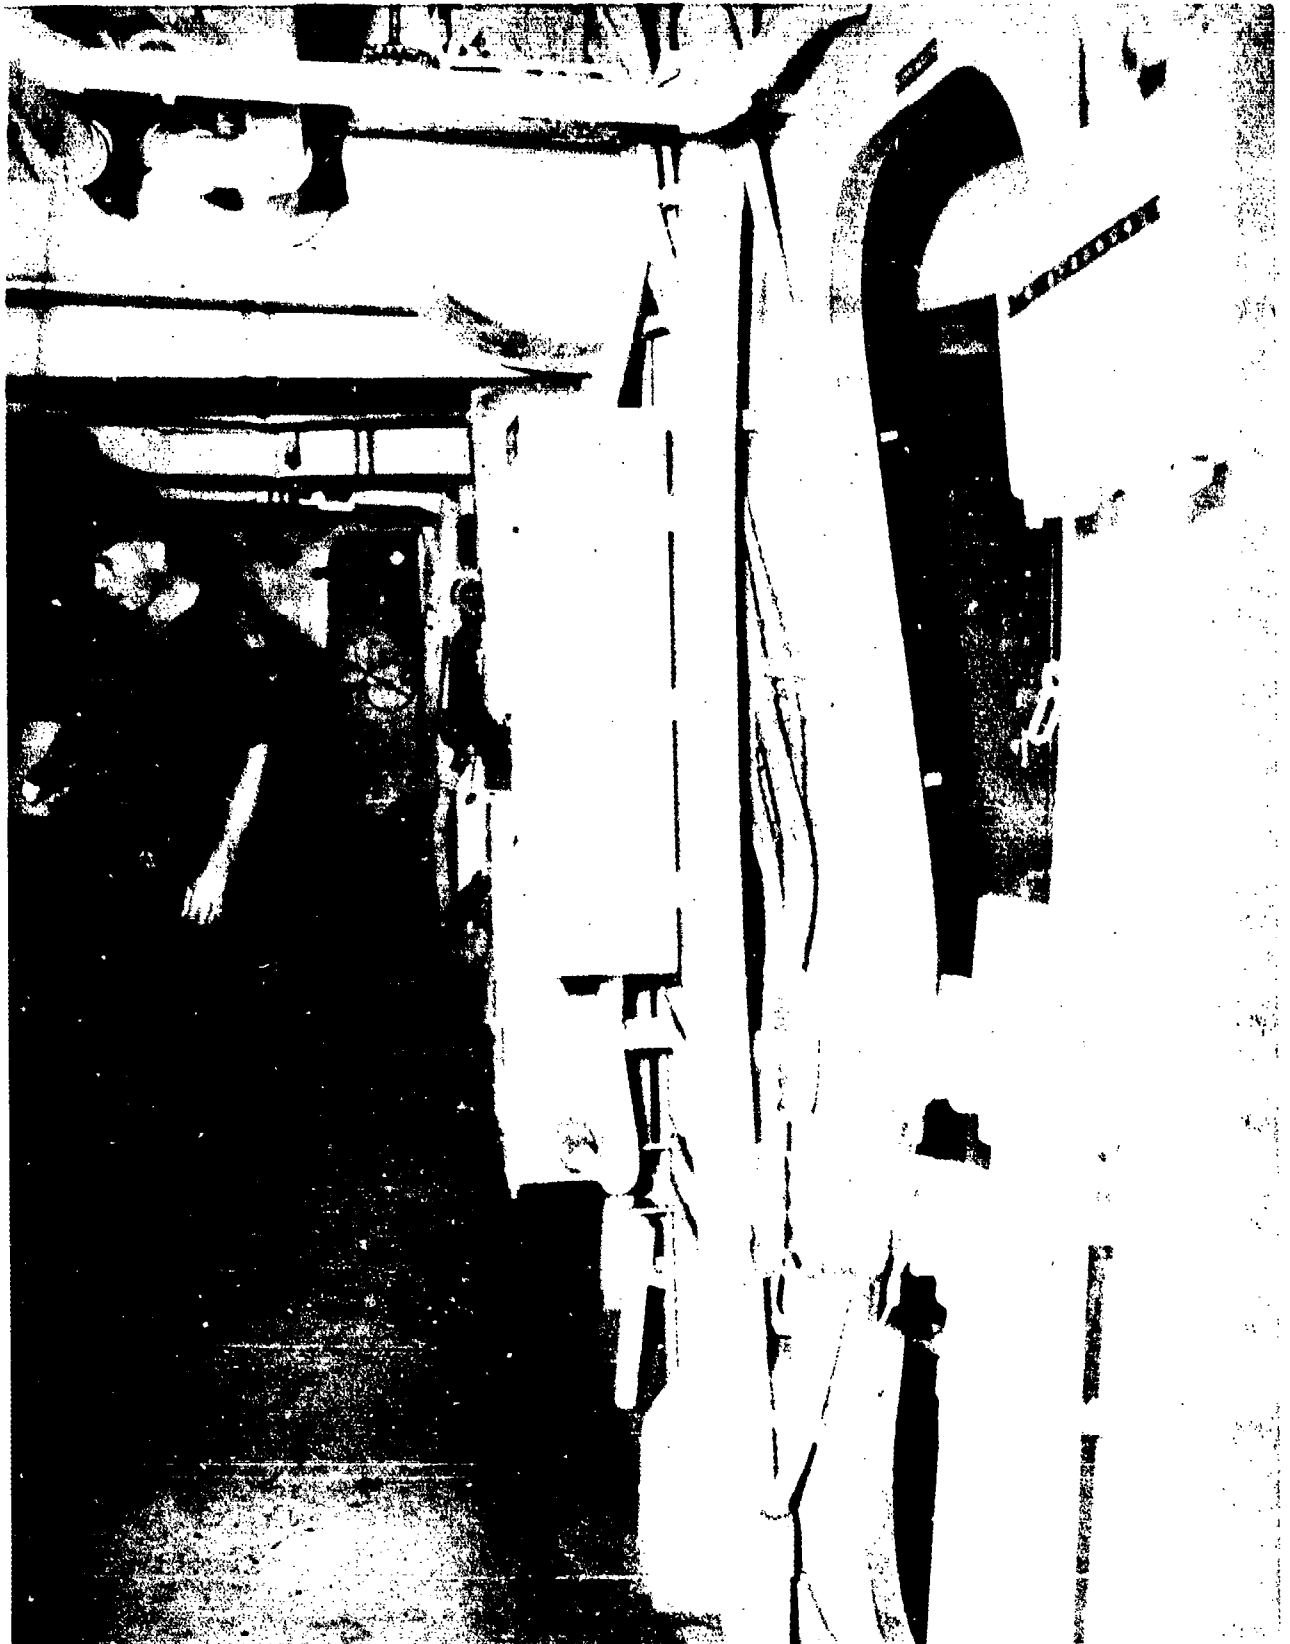
AA-CR-82-1916-6. Lighting distribution panel 2-72-2 mounted on angle bar extending from deck to deck frame 71 starboard side second deck. Supports buckled and cable partially pulled out of panel due to deflection in deck. View looking aft.

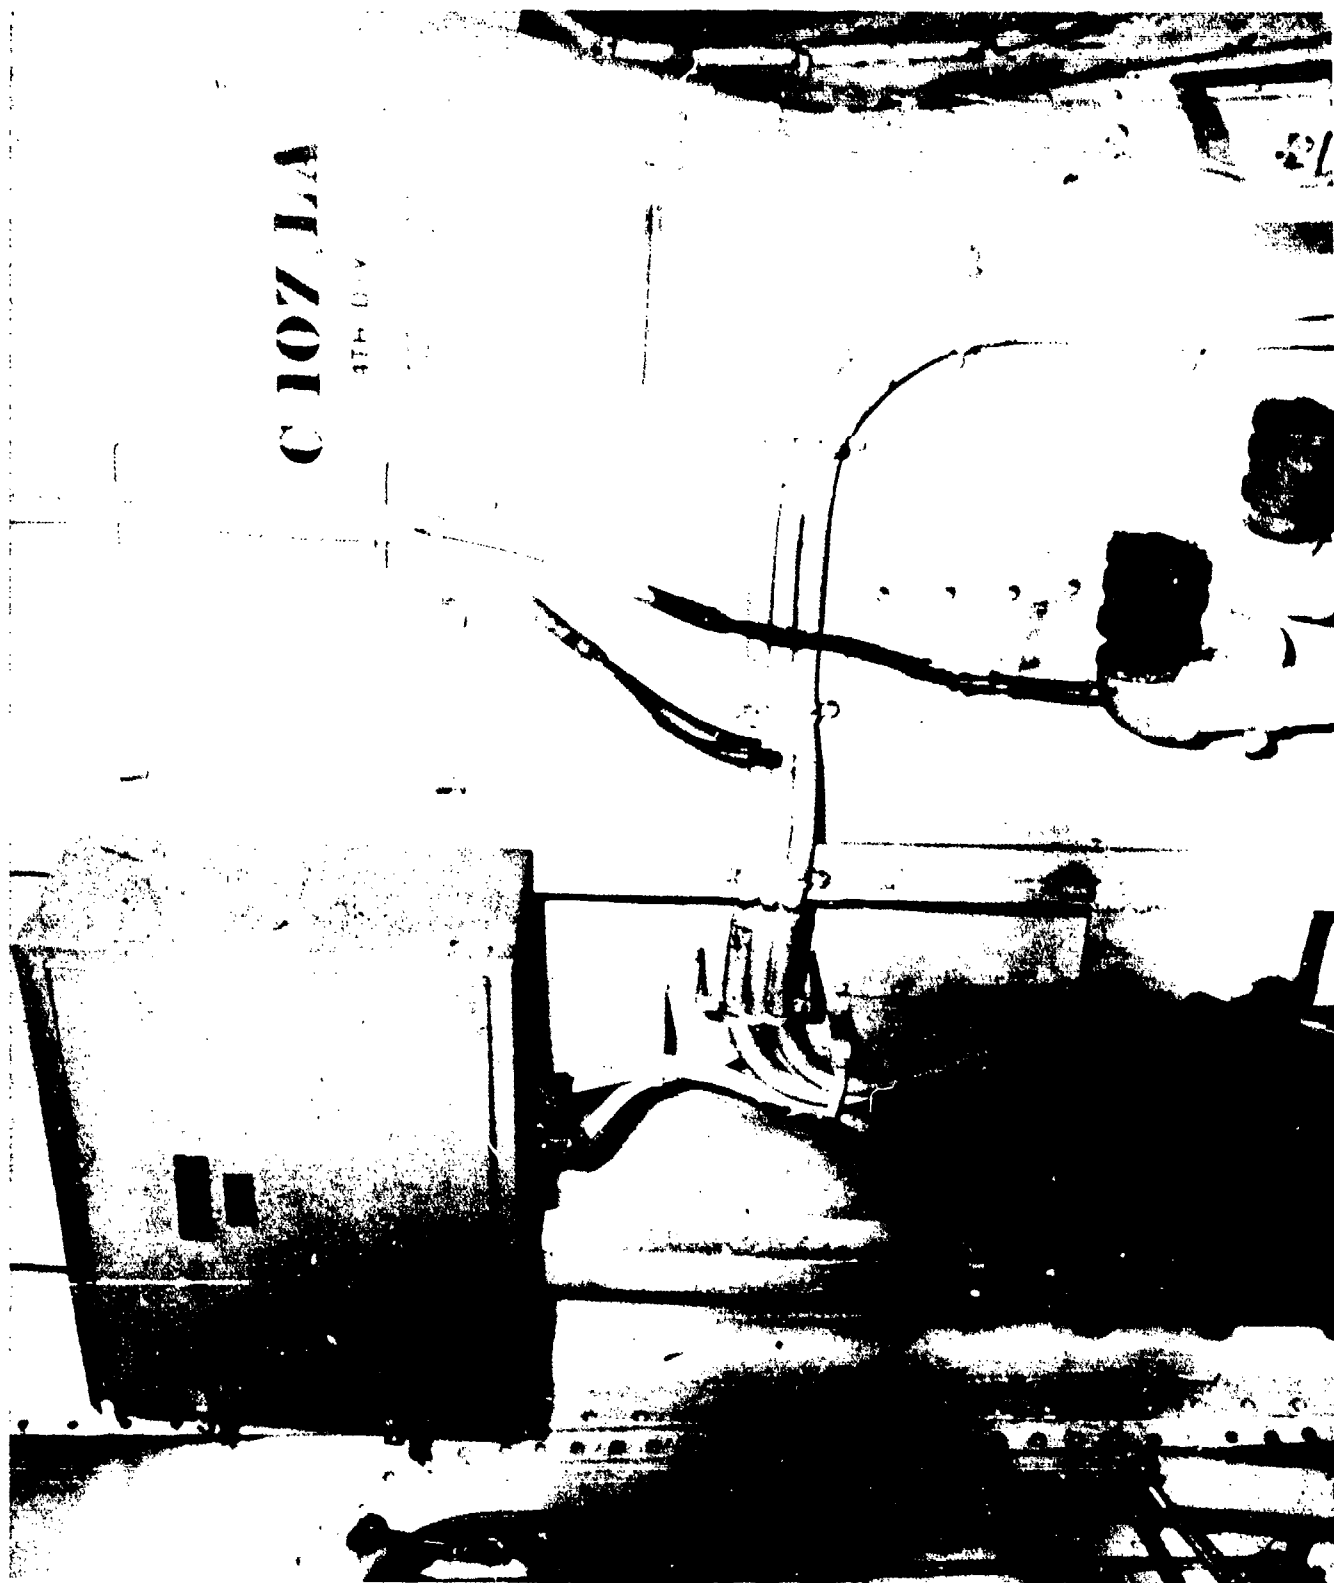
AA-CR-82-1918-12. Cable left hanging after a single phase transformer for 40MM machine gun system was dislodged from bulkhead by bomb blast pressure. Power panel and transfer switch were subjected to heat from fire in adjacent compartment. View looking aft to frame 136 main deck.

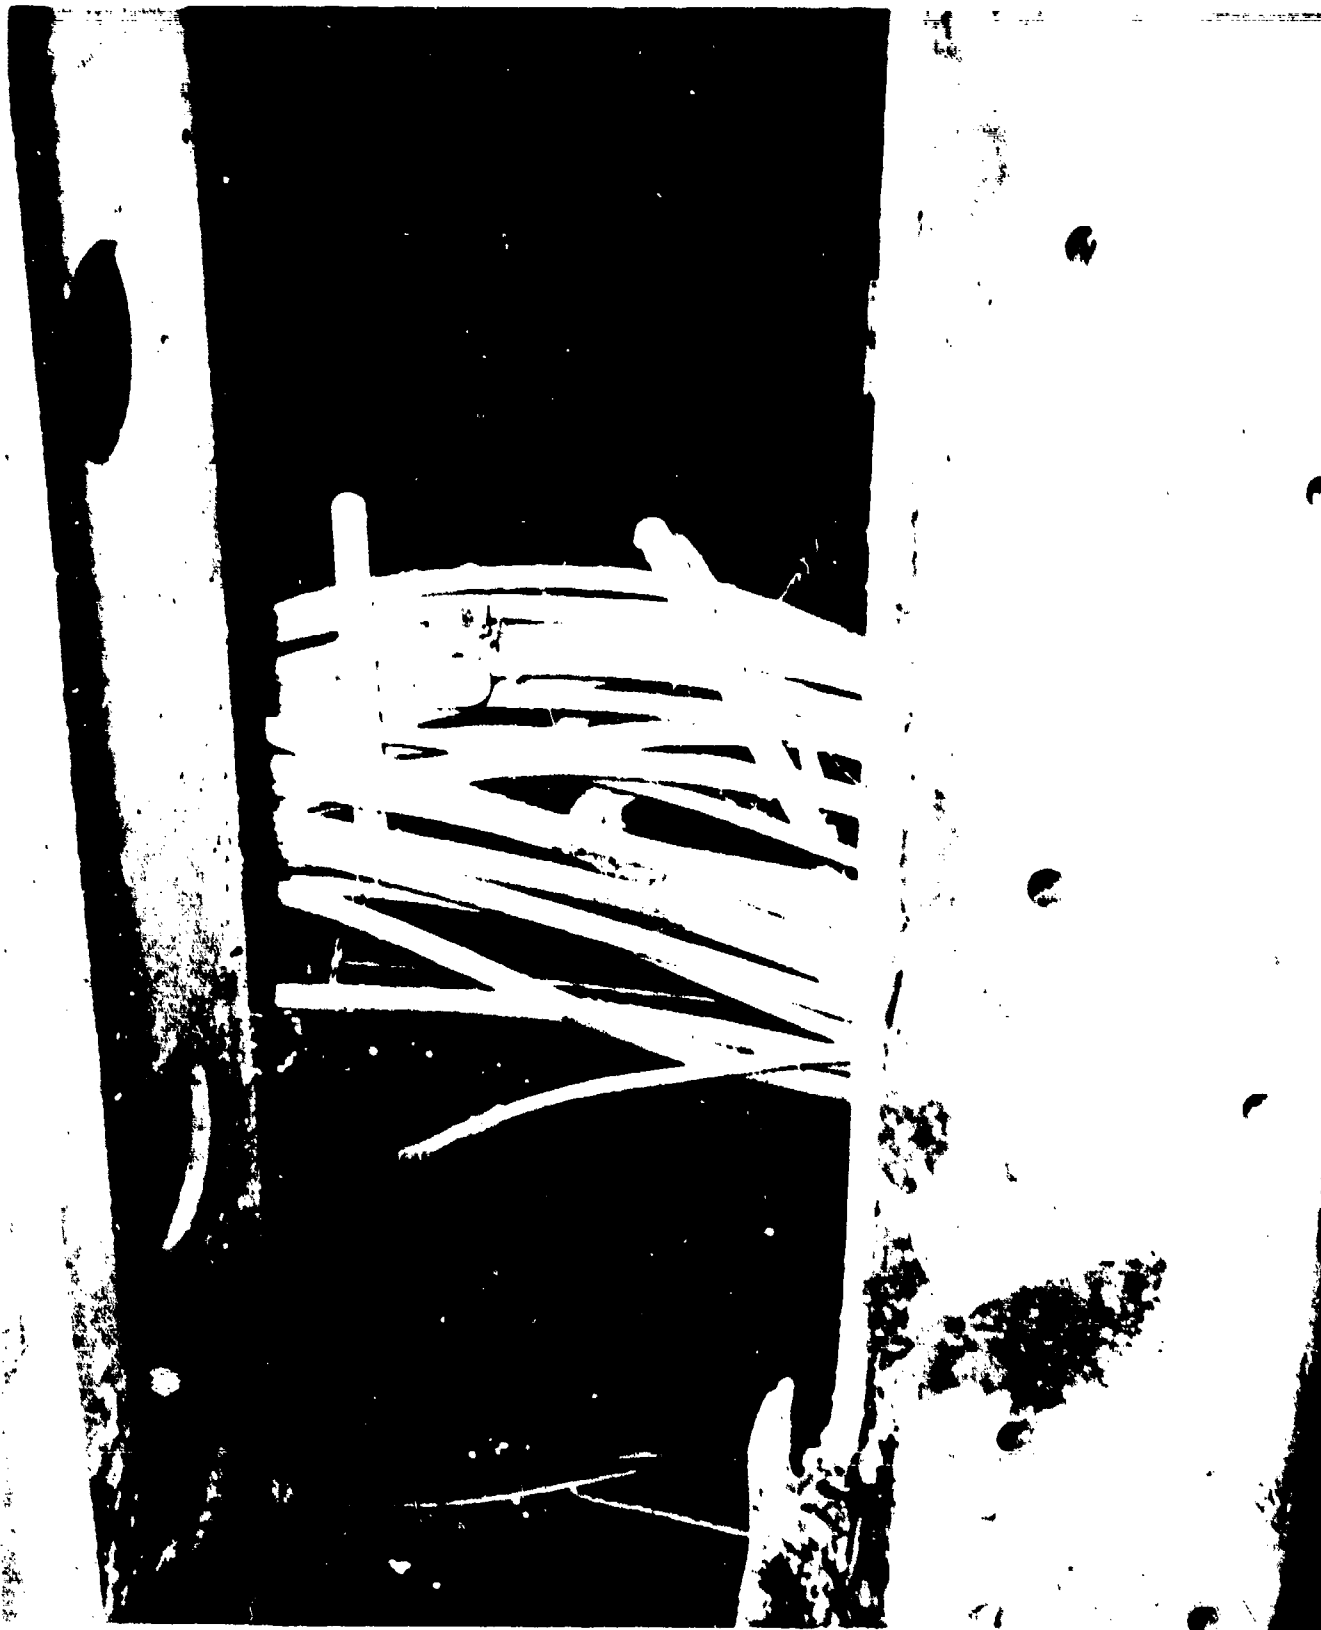
AA-CR-82-1920-1. Wireway under flight deck. Deck separated at expansion joint. Only two or three cables severed. Frame 112P side view looking down and outboard from flight deck.

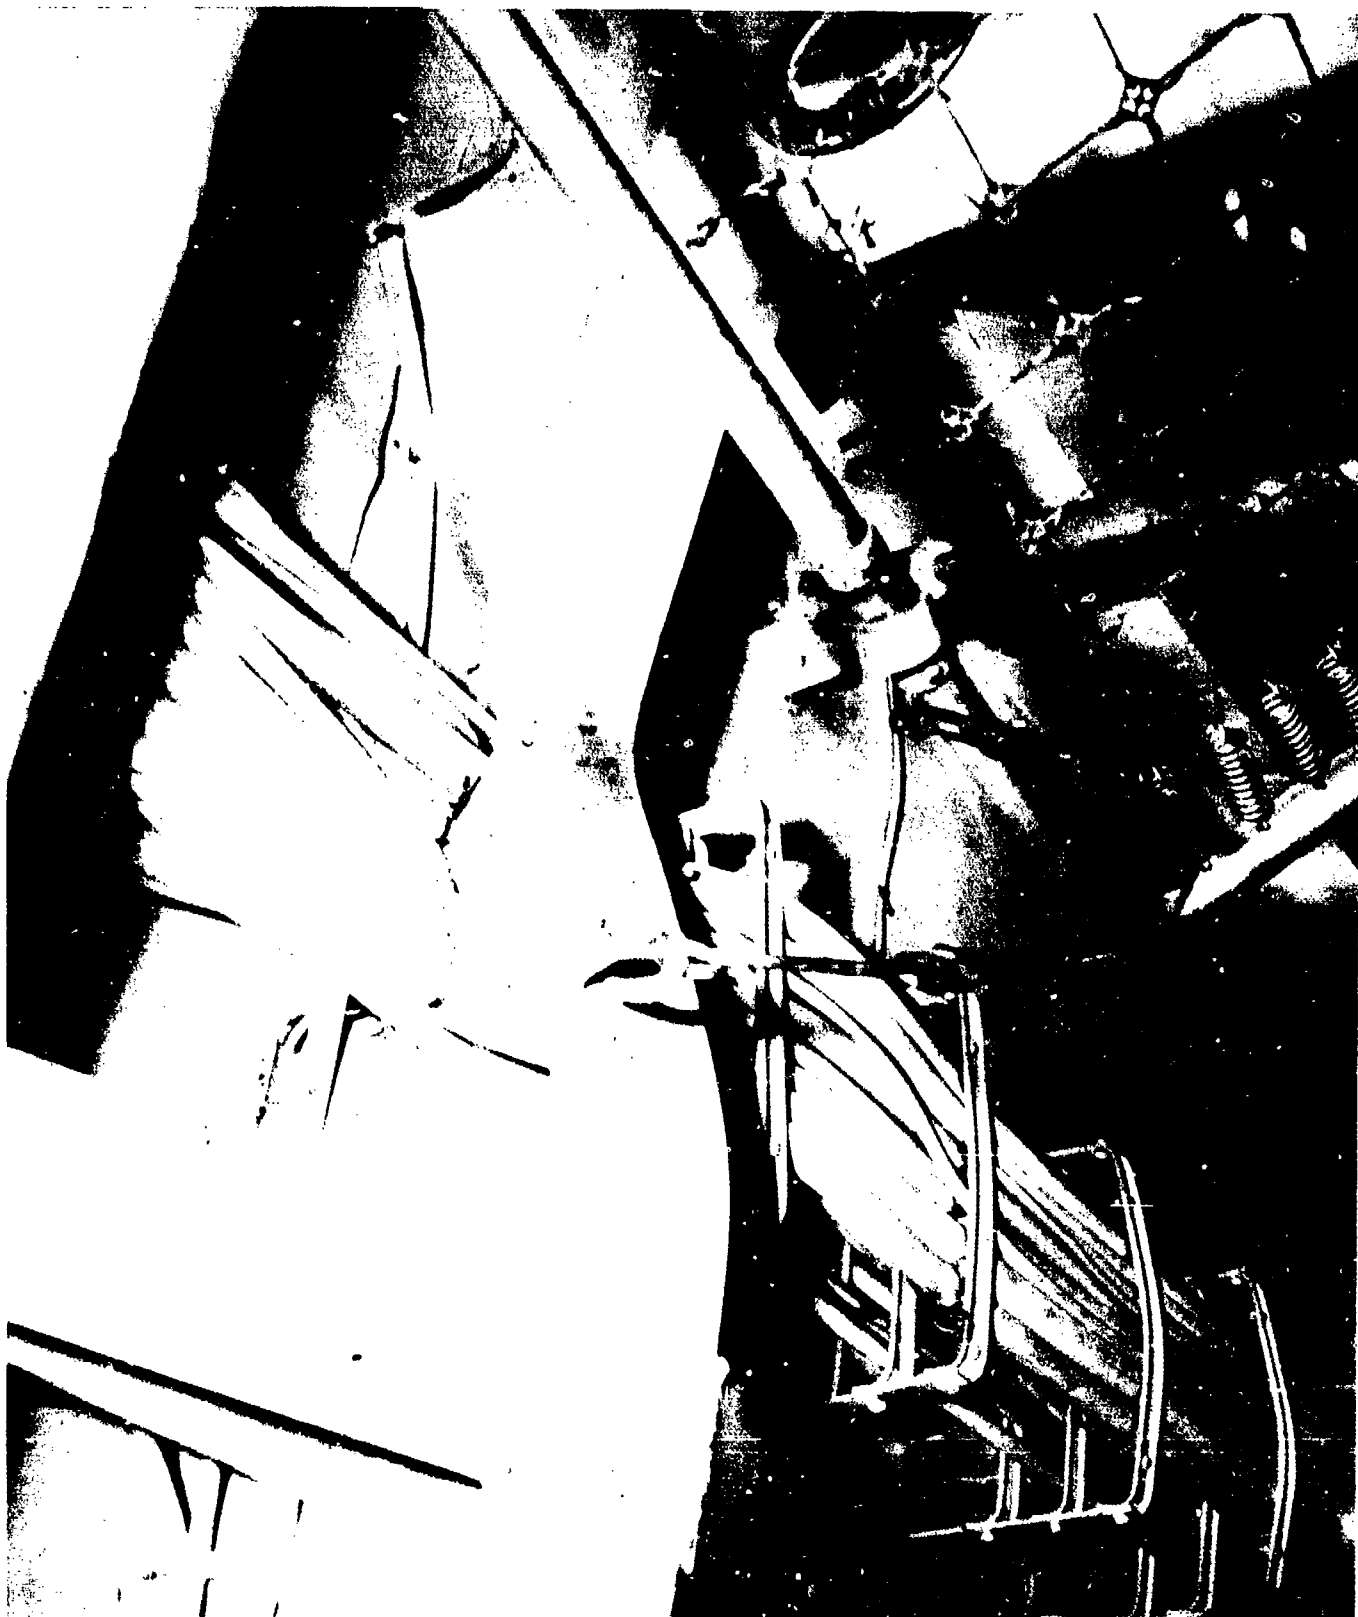
AA-CR-82-1916-9. Cable through lighting hole in girder frame 122, port side second deck. Cable damaged due to buckle in girder view looking up and aft.

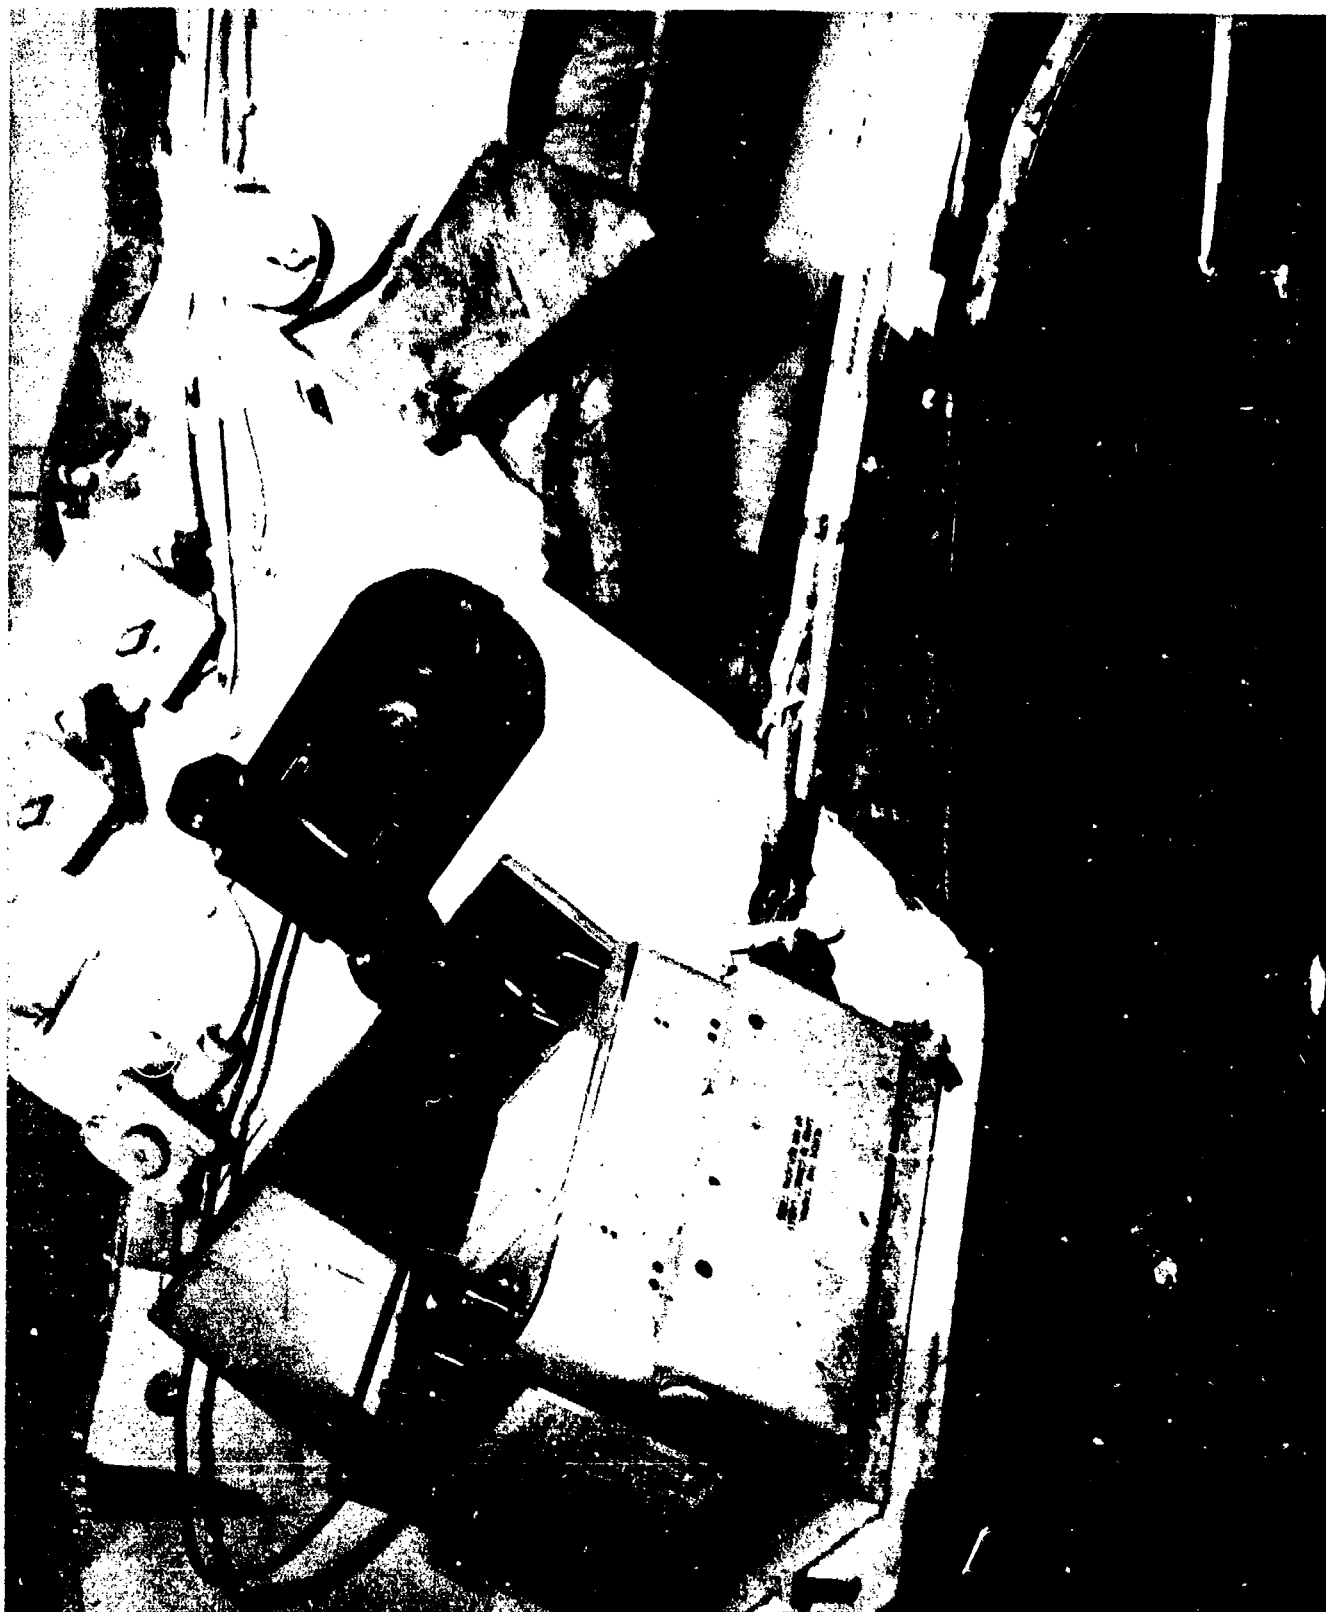
AA-CR-82-1920-5. Wiring and wiring equipment etc. on metal joiner bulkhead, frame 40 port side galley deck. Damage due to failure of bulkhead. View looking aft and to starboard.

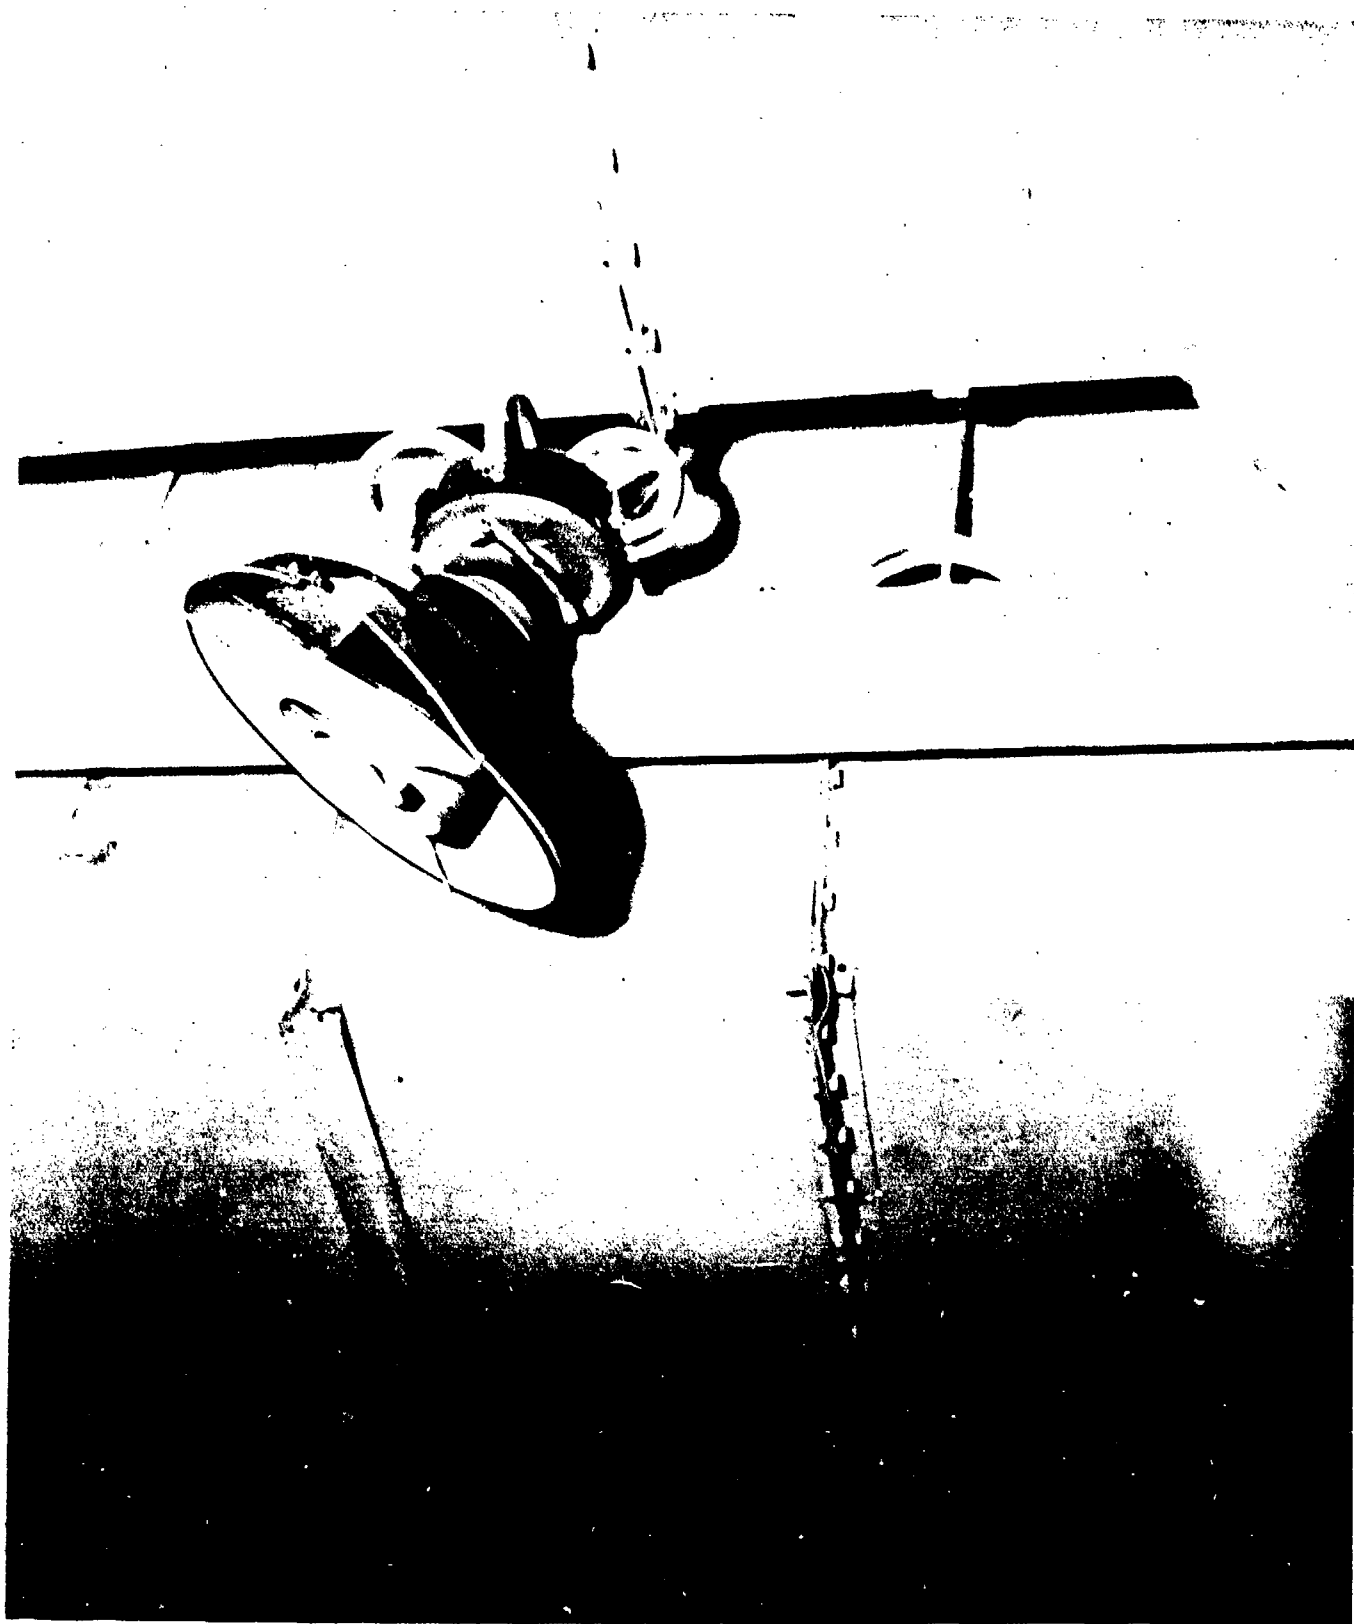
AA-CR-82-1920-7. Type "R-III" lighting fixture in state room frame 36 starboard side galley deck. Light damaged by falling clothes locker. View looking aft.
